Corrosion Fitting Seized Cap Removal

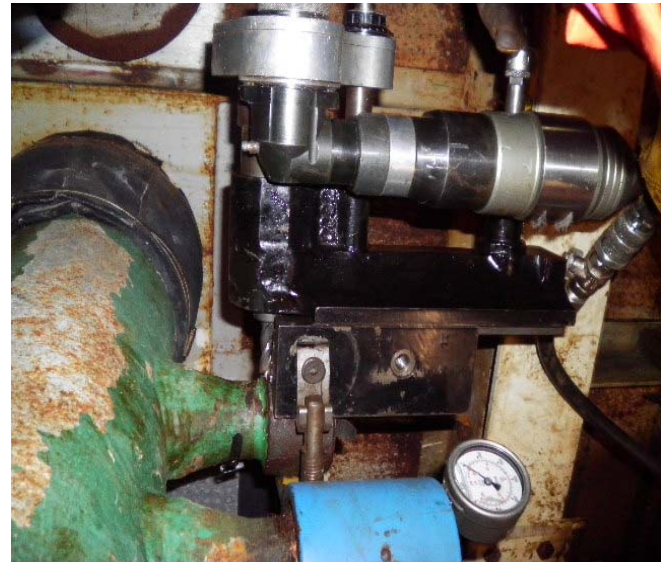
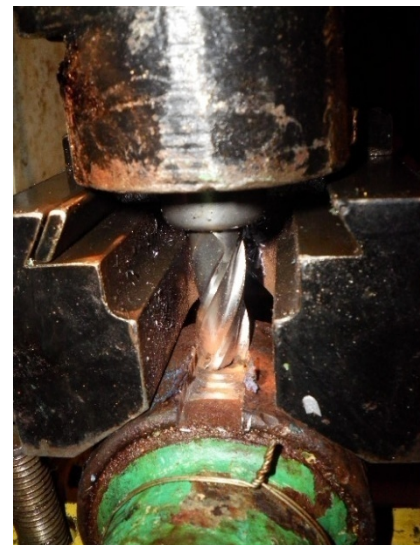
A portable keymill machine complete with vee block mounting arrangement is clamped to the seized cap. Using a multi flute cutting tool a slot, or if necessary slots, are milled into the cap to expose the threaded portion of the fitting to release the cap for removal.
