Davit Arm Padeye Machining

Moss were approached by the owners of a North Sea offshore supply vessel with regard to the machining of the lifeboat launching davit arm padeyes.

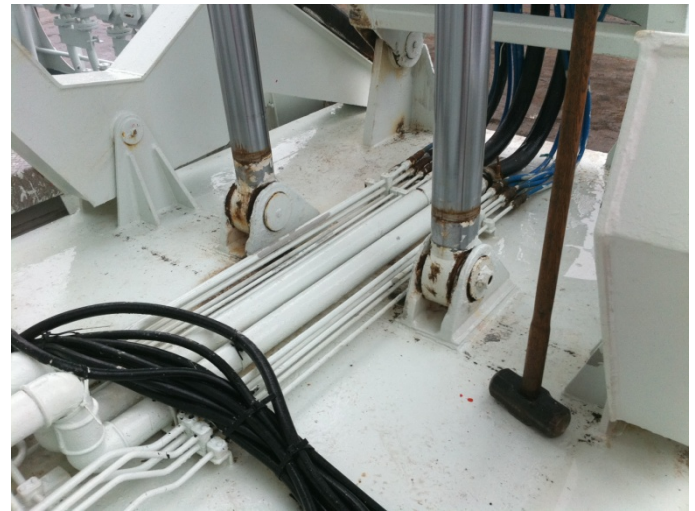
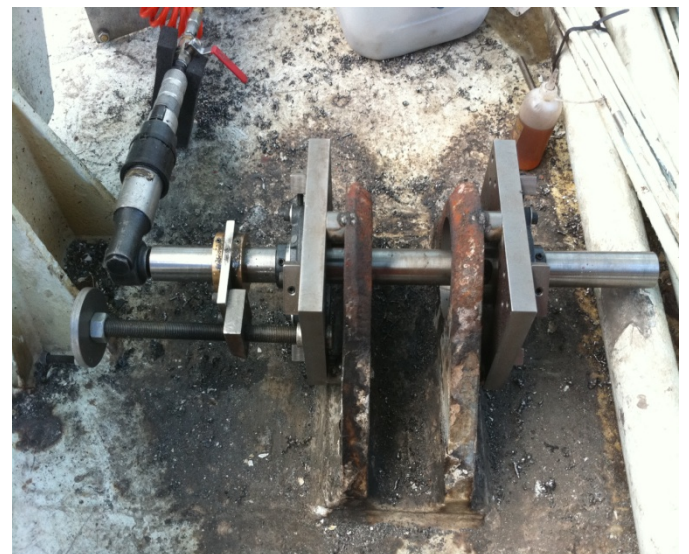
The locating pins and padeye bushes that the fixed ends of the davit arms locate into had worn causing unnecessary strain on the hydraulic system and potential issues when launching the lifeboats. Both sets of padeyes (4 in total) had to be machined to allow new bushes and pins to be installed.

Two sets of specially manufactured line boring equipment together with competent Moss technicians were mobilised so that each pair of padeyes could be machined simultaneously .

The padeye bores were machined to remove the old bushes and sized suitable for installing the new bushes. Once the new bushes had been welded into the padeyes the line boring equipment was set up again. The equipment was then used to machine the bores of the new padeye bushes inline to provide a running fit for the new location pins.
